## CATPHAN Low Contrast - 515 Module Report

Filename	C:\RIT\RIT113V4\Demo Images\Radia Demo Images\CATPHAN\CTP515
Institution	Chlidrens Hospital
Station	CTER_OC0
kVp	140
mA	400
Protocol	1.1 Physics Test
Filter	
Convolution Kernel	STANDARD
DICOM Slice Thickness(mm)	5
SOP Instance UID	1.2.840.113619.2.55.3.51037702.5388.1181828433.292.16
Slice Location	0

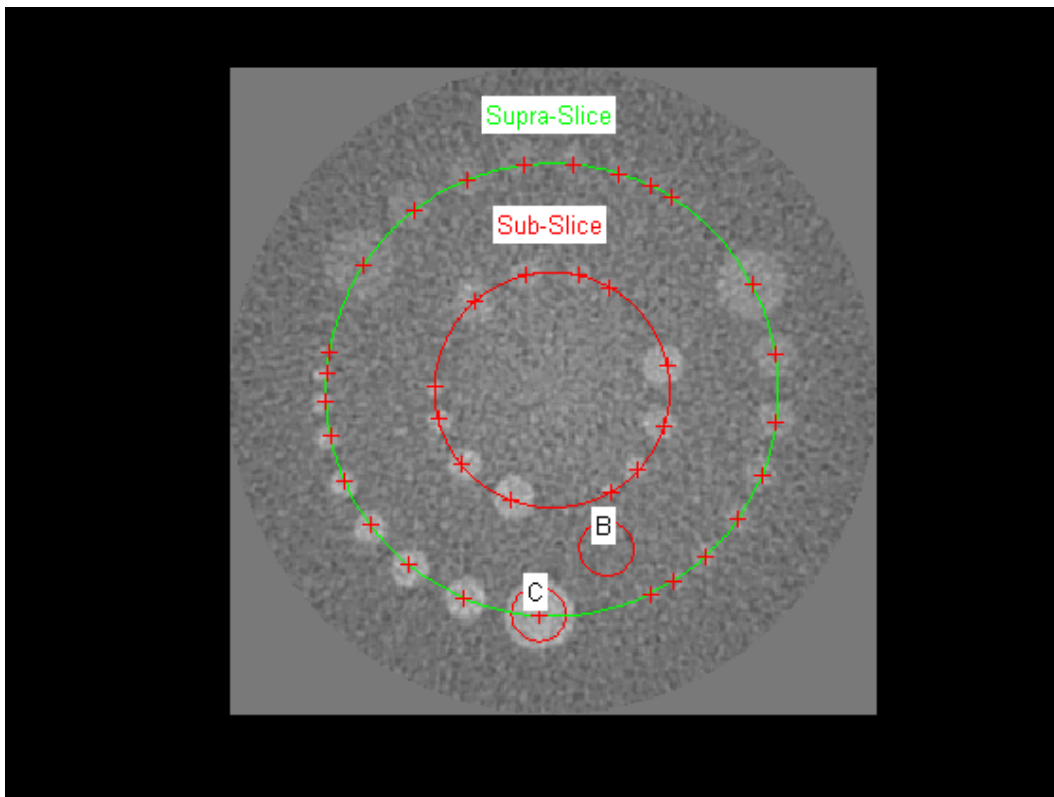
### Analysis Image

Band	Number of Objects Detected (Nominal)	Pass/Fail
Subslice	12 of 12 (10)	Pass
Supraslice	25 of 27 (23)	Pass

CNR	Minimum CNR	Pass/Fail
4.04	2	Pass
