ACR MR Phantom - Slice 10 Report

OVERALL RESULTS

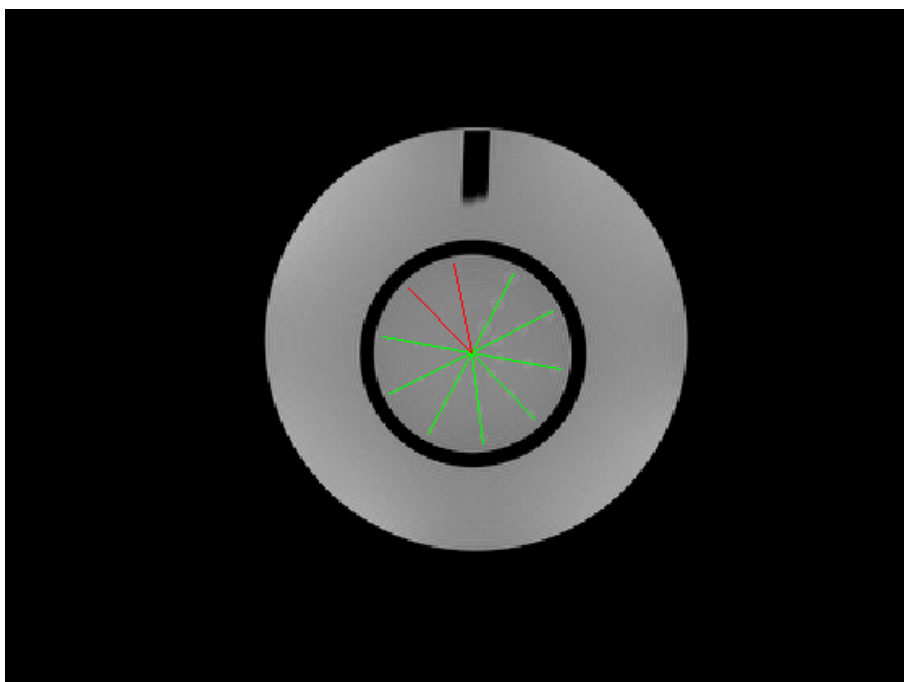
Analysis Image

Spokes Detected - Slice 10

Number of Spokes Detected	Minimum Nominal Number of Spokes Detected	Pass/Fail
8	10	Fail

Spoke Number	Angle(deg)	CNR Inner	CNR Middle	CNR Outer
1	28.00	4.27	3.86	2.29
2	63.00	4.76	3.13	2.80
3	100.00	5.35	3.17	3.06
4	136.00	5.34	3.35	3.10
5	173.00	4.92	2.84	4.37
6	209.00	7.03	4.67	2.94
7	245.00	5.08	3.54	5.99
8	281.00	3.46	2.40	5.10
9	317.00	2.51	1.77	1.22
10	349.00	1.92	1.52	2.28
