Wedge Check Test Report

Image File	C:\RIT\RIT113V4\Demo Images\Wedge and Constancy\Wedge\RI.1.2.246.352.81.3.54482683.17088.17566.132.147.dcm
------------	---

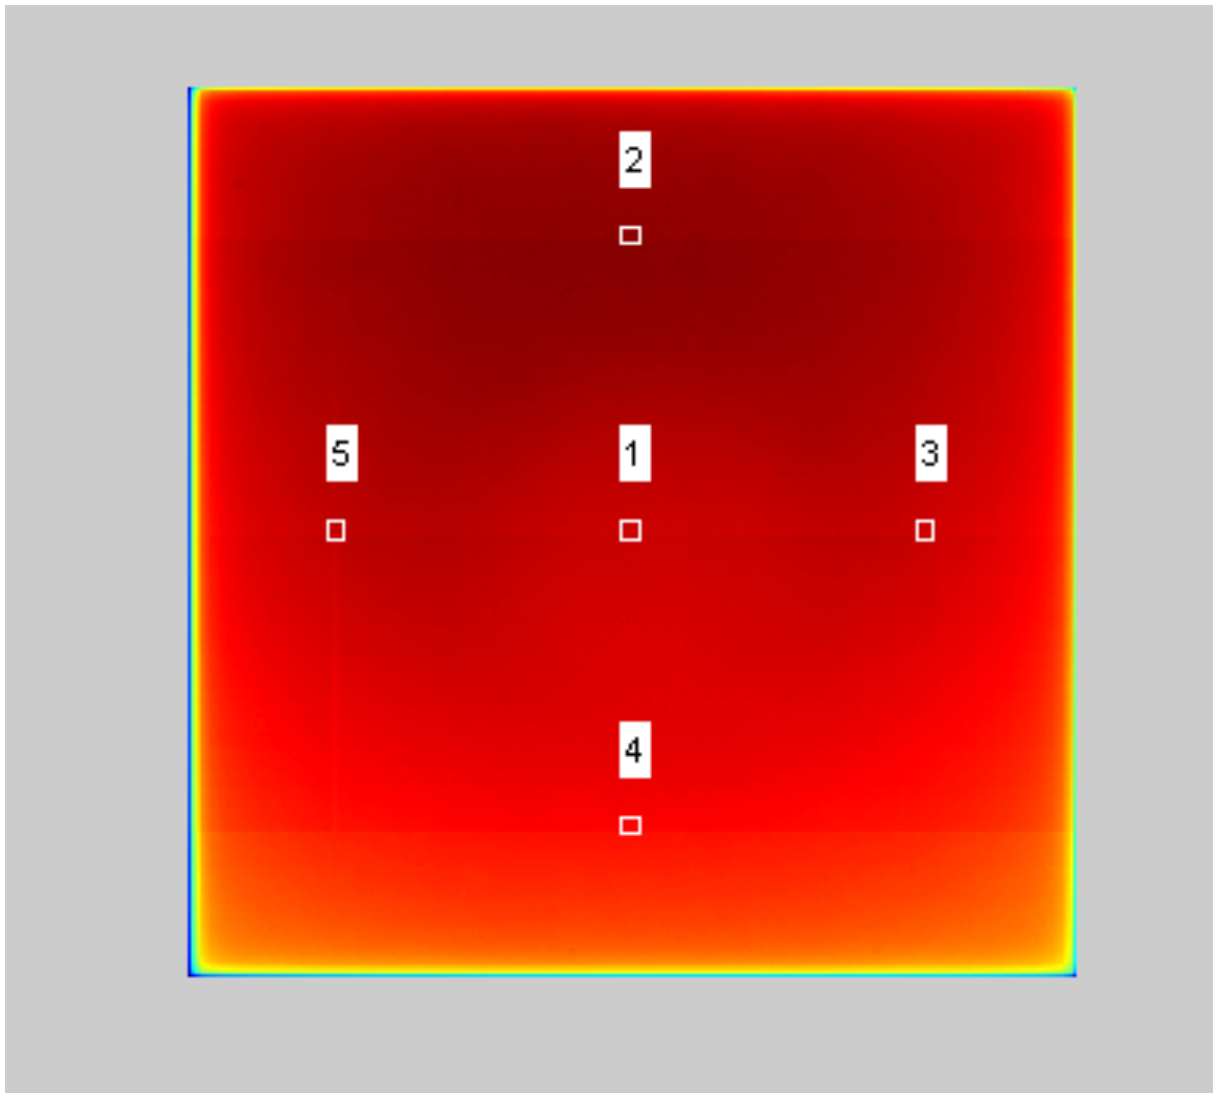
Analyzed Image

Measurement	Value
Ratio: ROI-2/ROI-1 (ROI 3 mm square)	1.05
Ratio: ROI-3/ROI-1 (ROI 3 mm square)	1.00
Ratio: ROI-4/ROI-1 (ROI 3 mm square)	0.95
Ratio: ROI-5/ROI-1 (ROI 3 mm square)	1.01

SID	100 cm
Energy Level	6.00 MV
